BYERS PIPE

BULLETIN No. 30

An Investigation of Pipe Corrosion

Showing service records of iron, steel
and brass pipe used for hot and cold
water supply lines in 129 Pittsburgh
Apartment Buildings

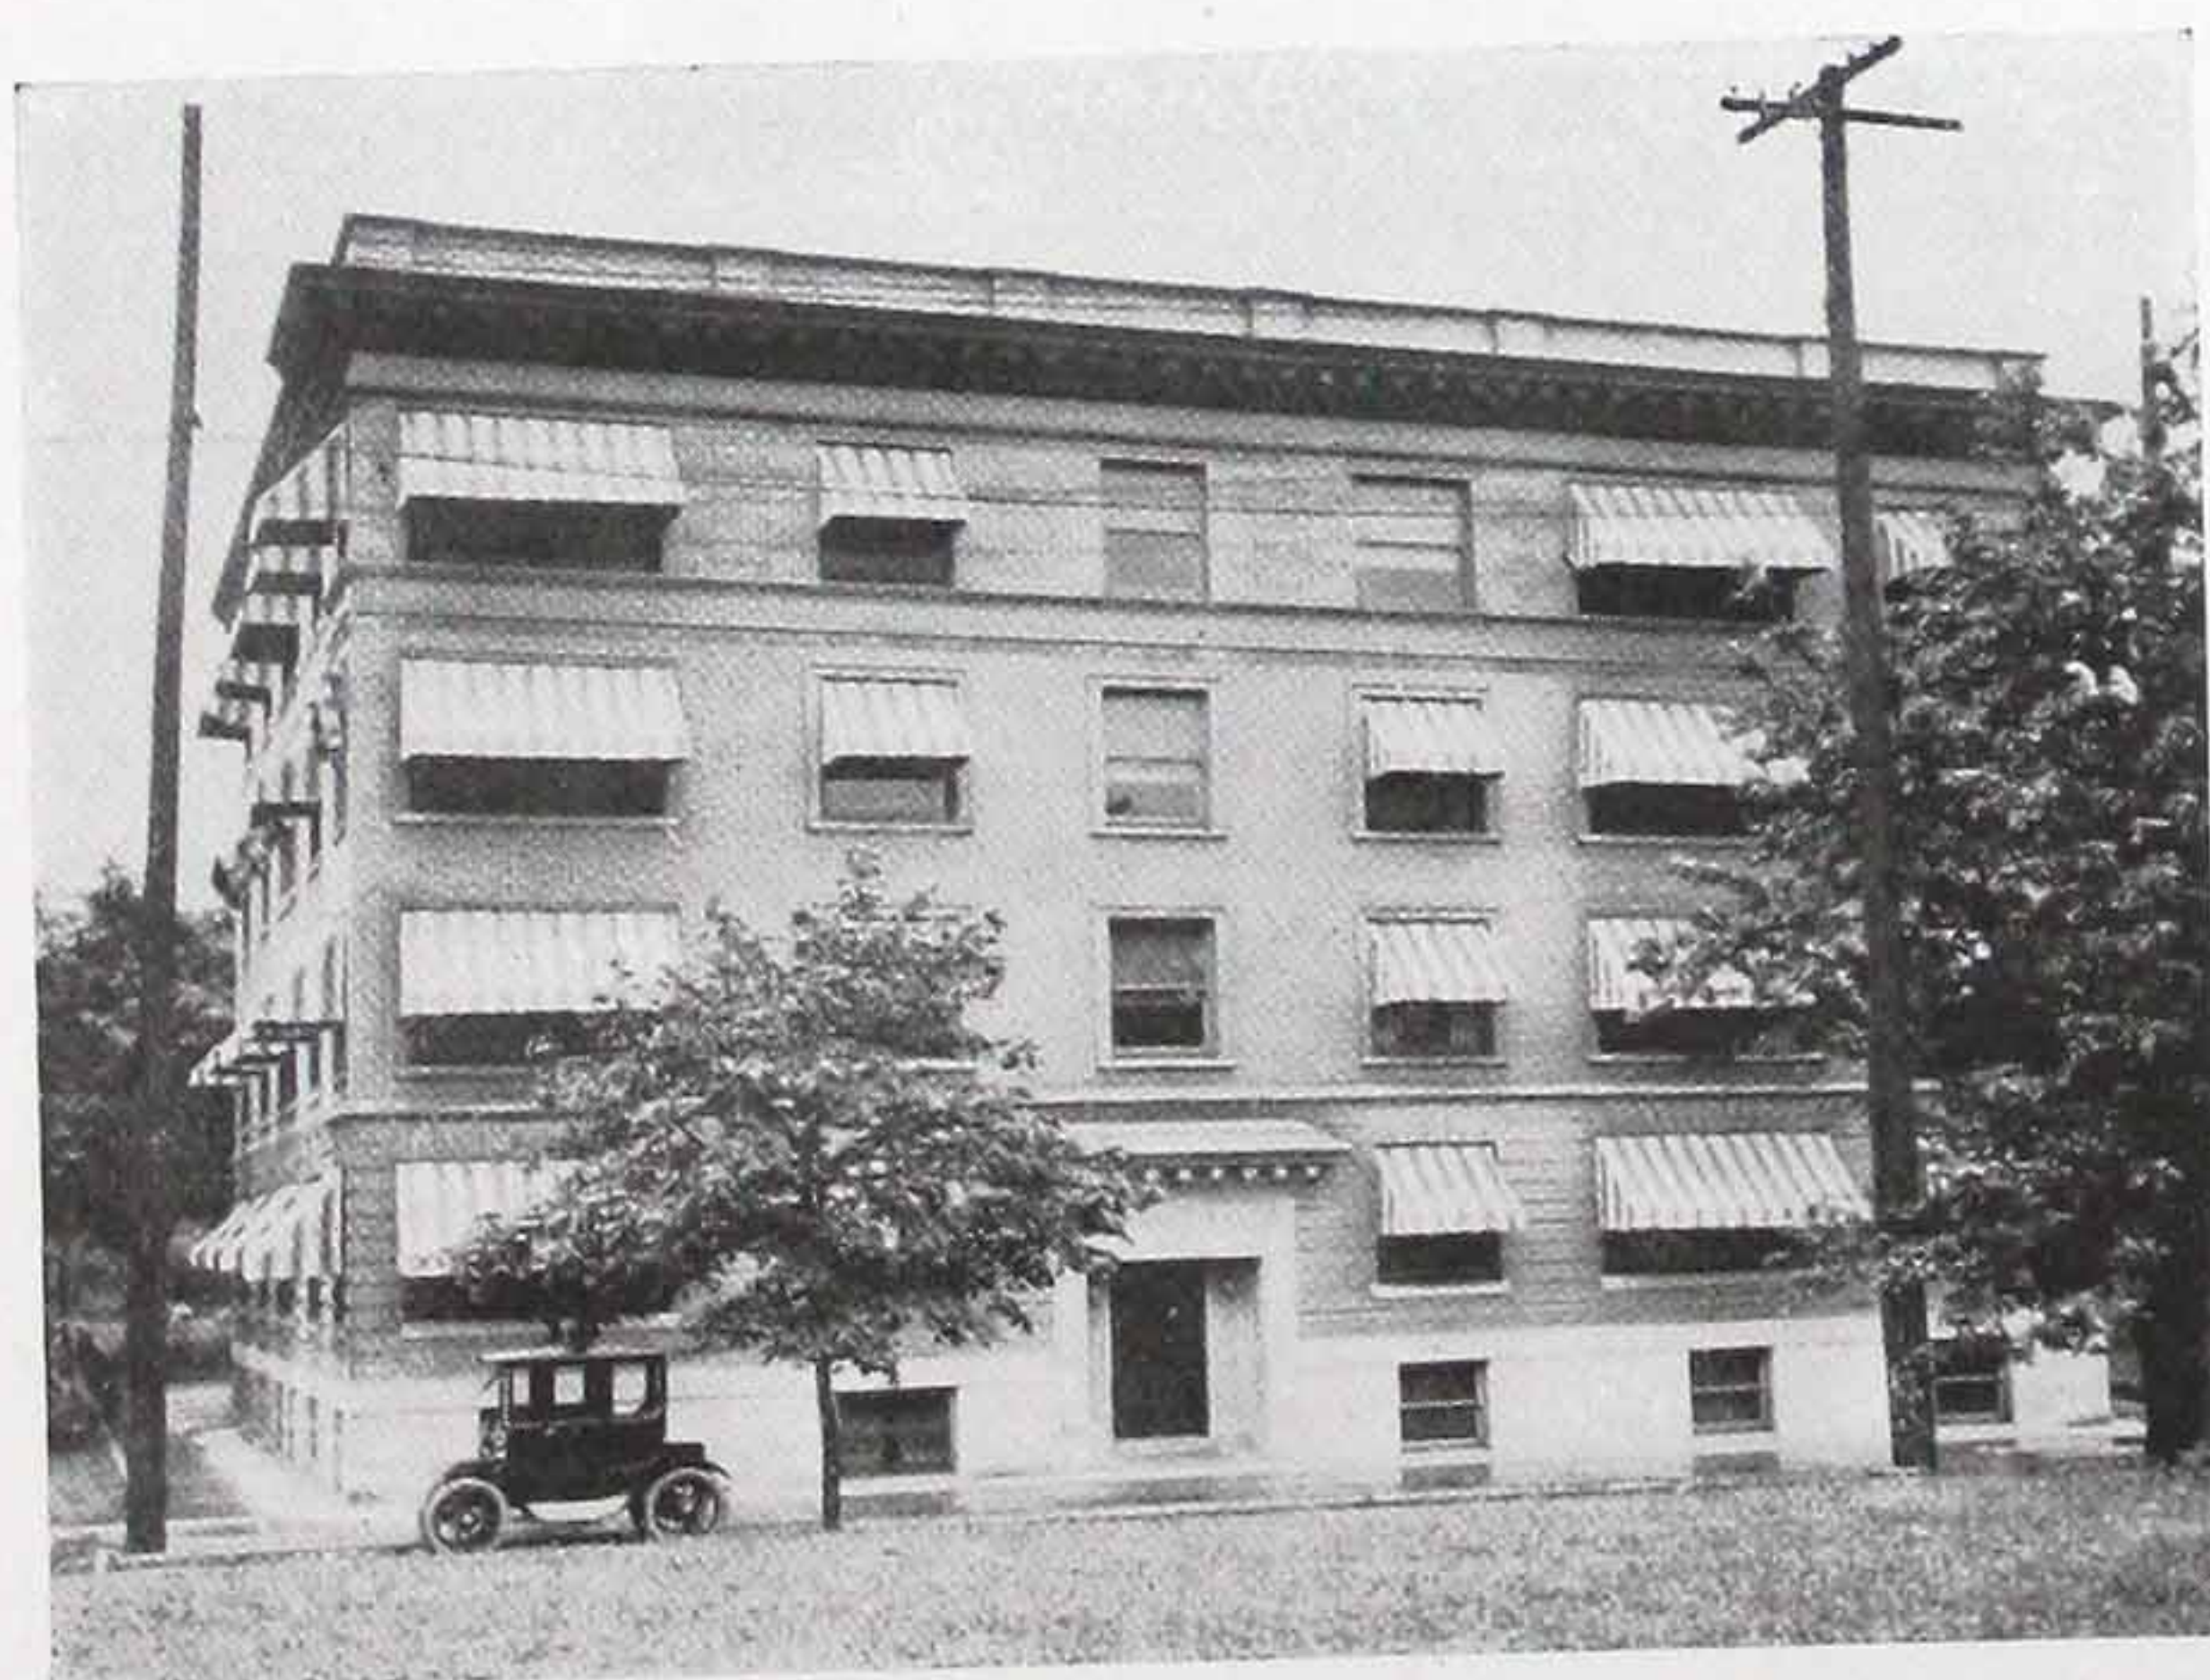
D'Arlington Apartments, erected 1909, equipped with brass pipe. The hot water lines are badly corroded and pitted after 8 years' service. Record No. 7, Brass Installations, page 17.

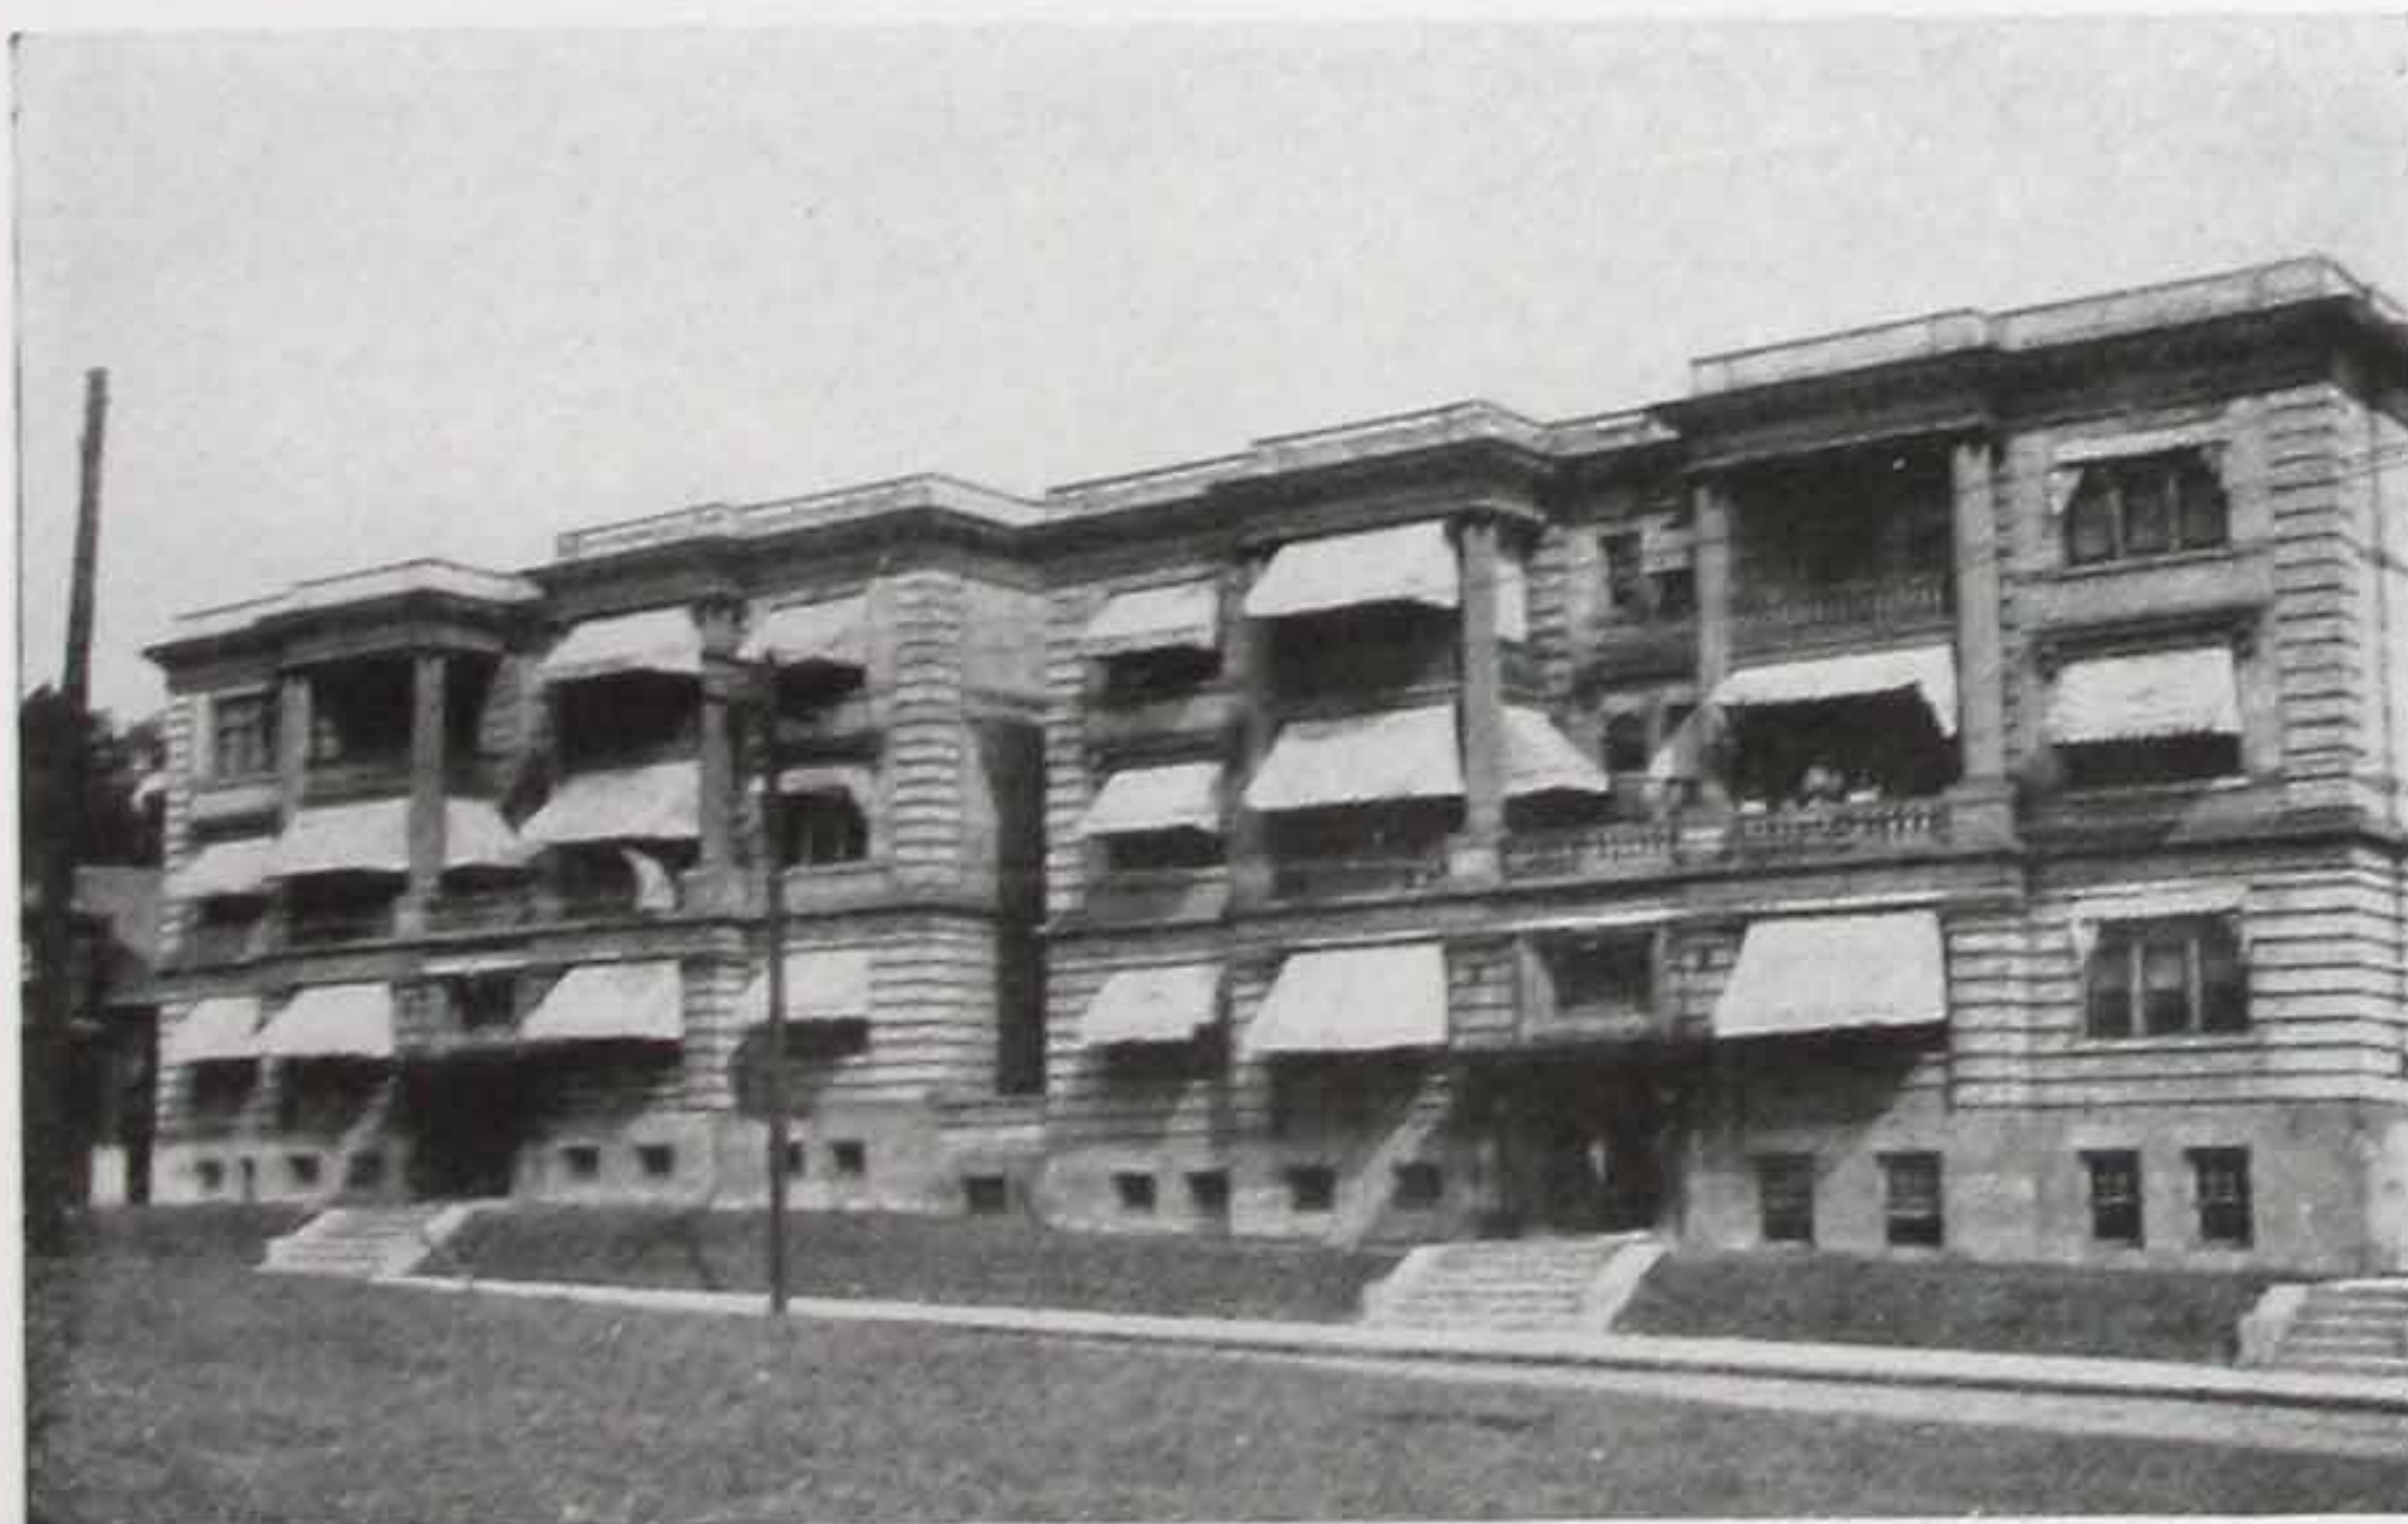
Lafayette and Cambridge Apartments, McKee Place, erected 1902, equipped with wrought iron pipe. Most of the hot water mains were replaced in 1917, after 14 years' service. Record No. 42, Wrought Iron Installations, page 16.

42. Lafayette and Cambridge Apts. McKee Place.	12	1902	Most of hot water mains in basement replaced 1917.	14 yrs.	14 yrs. Still good	14 yrs. Still good

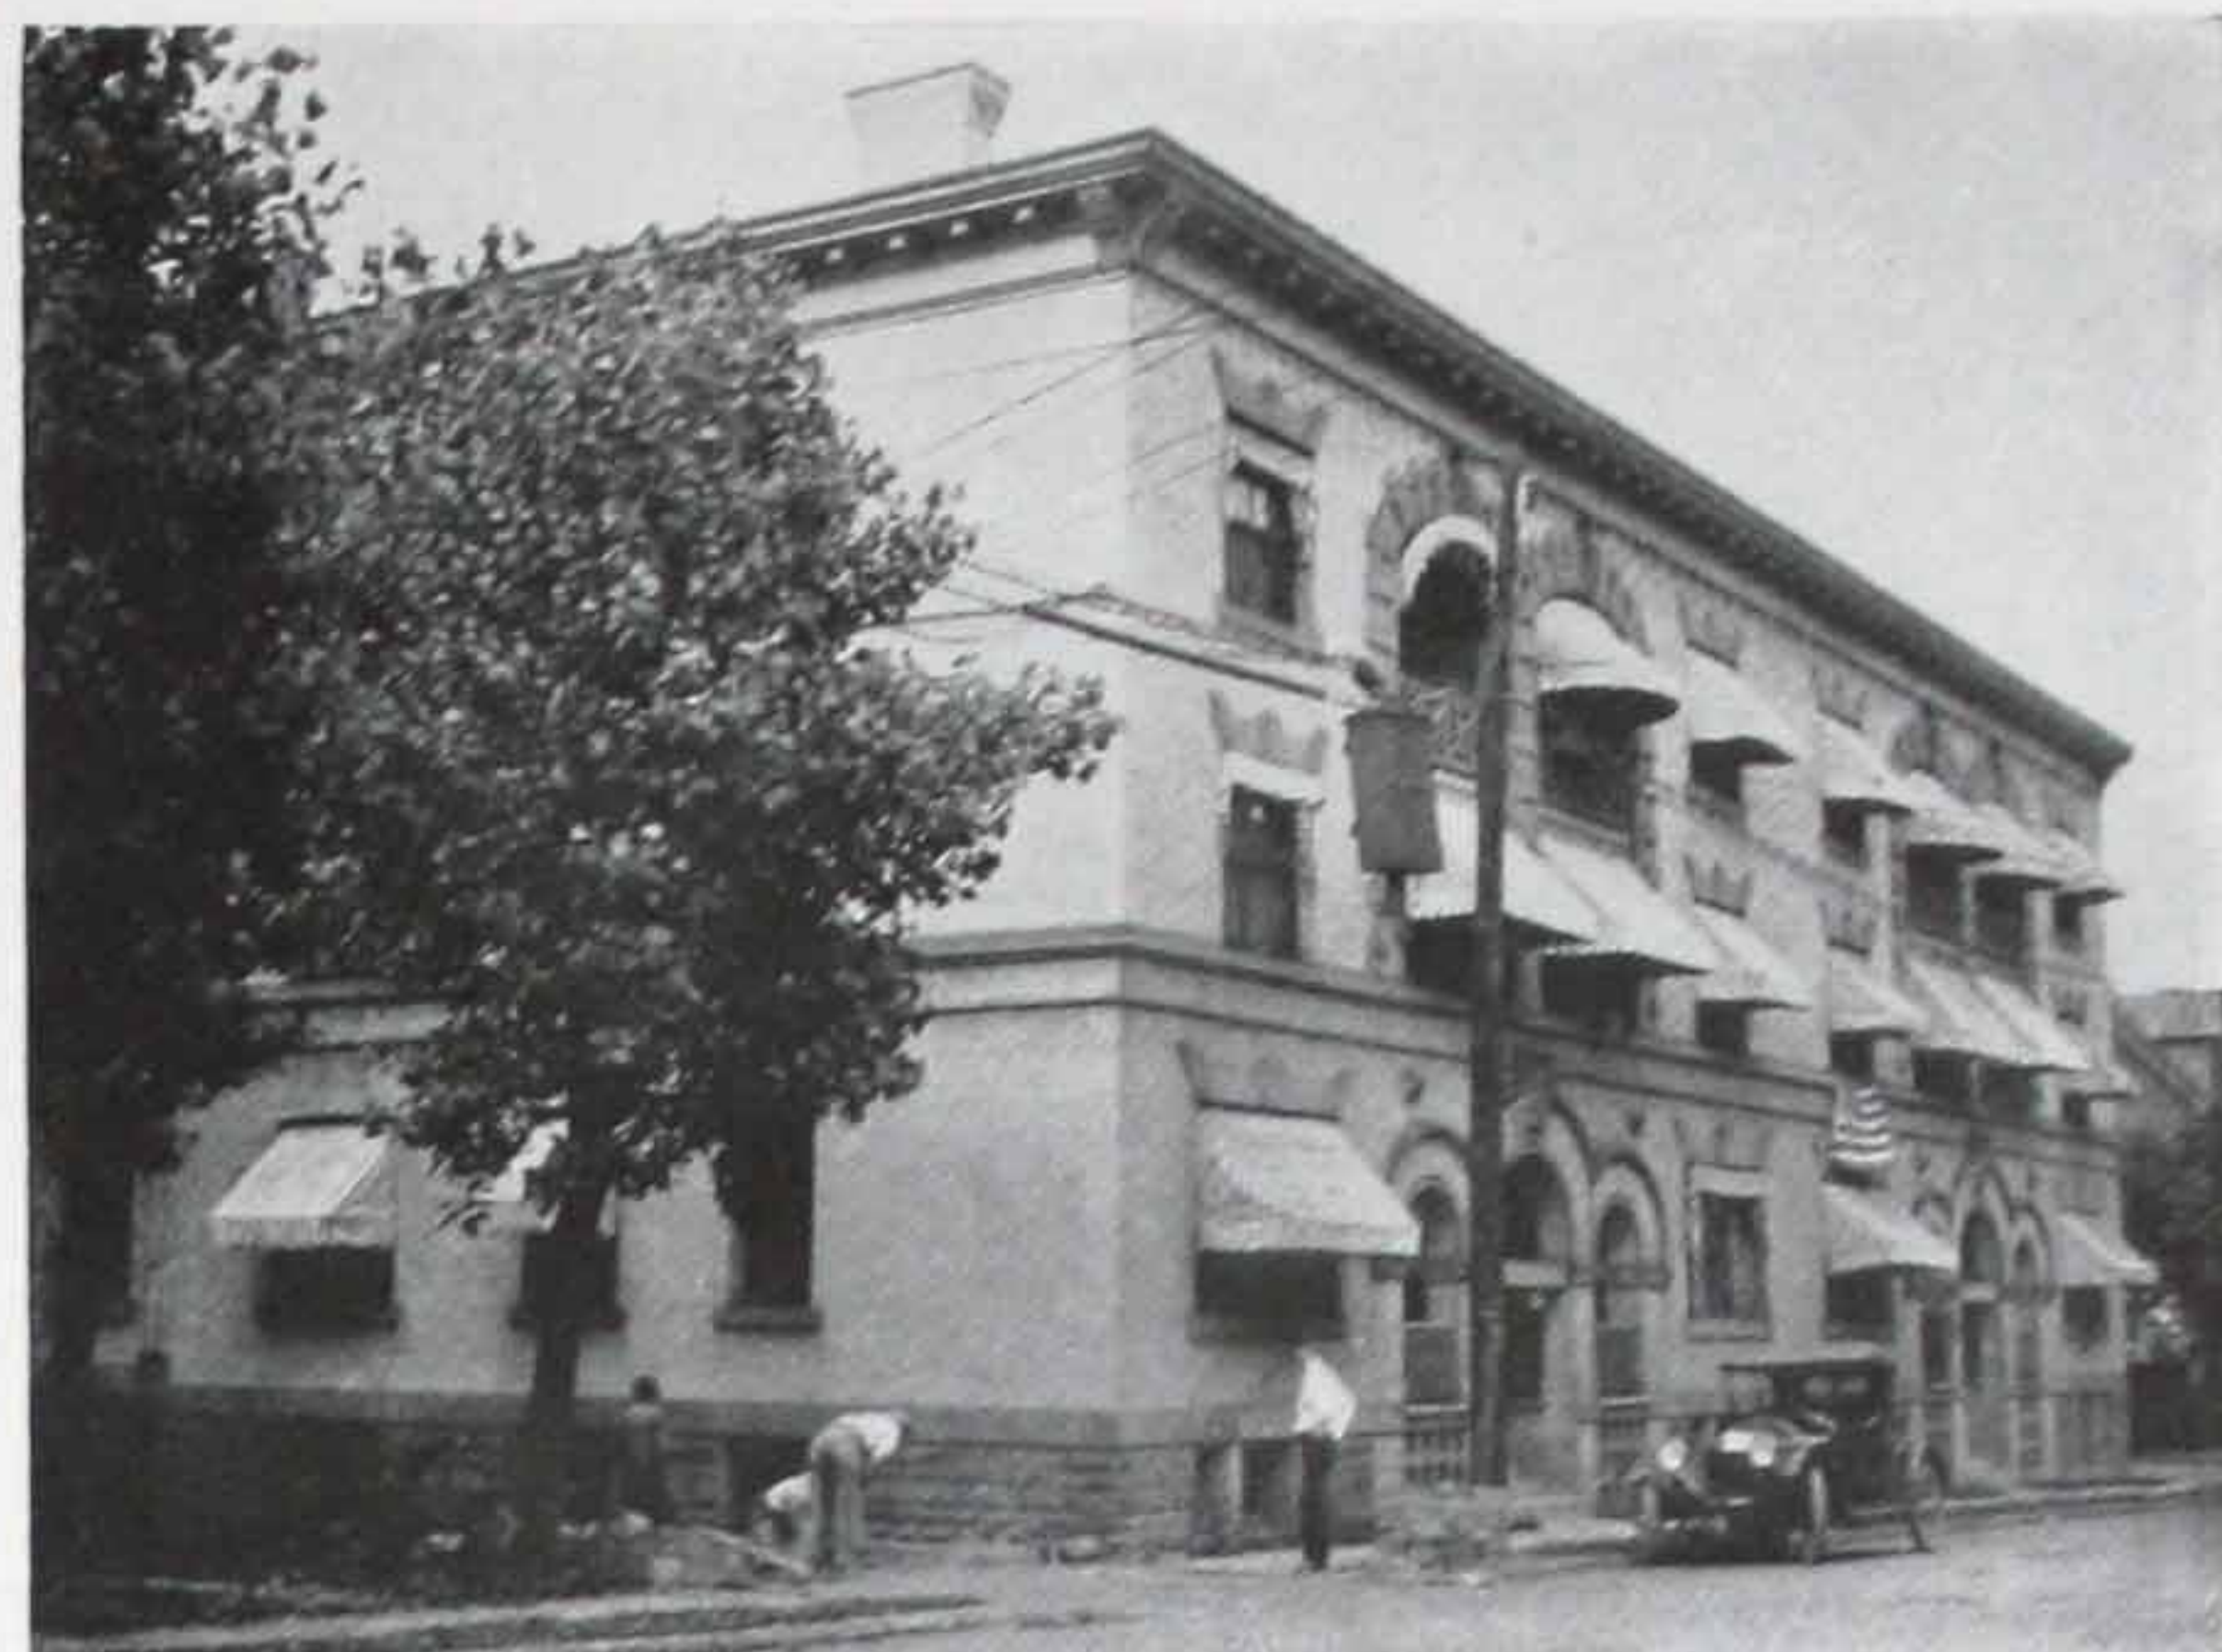
The Howe and Kent Apartments, erected 1907. The hot water mains are of brass and already show pitting. See records No. 16-17 on brass piping, page 18.

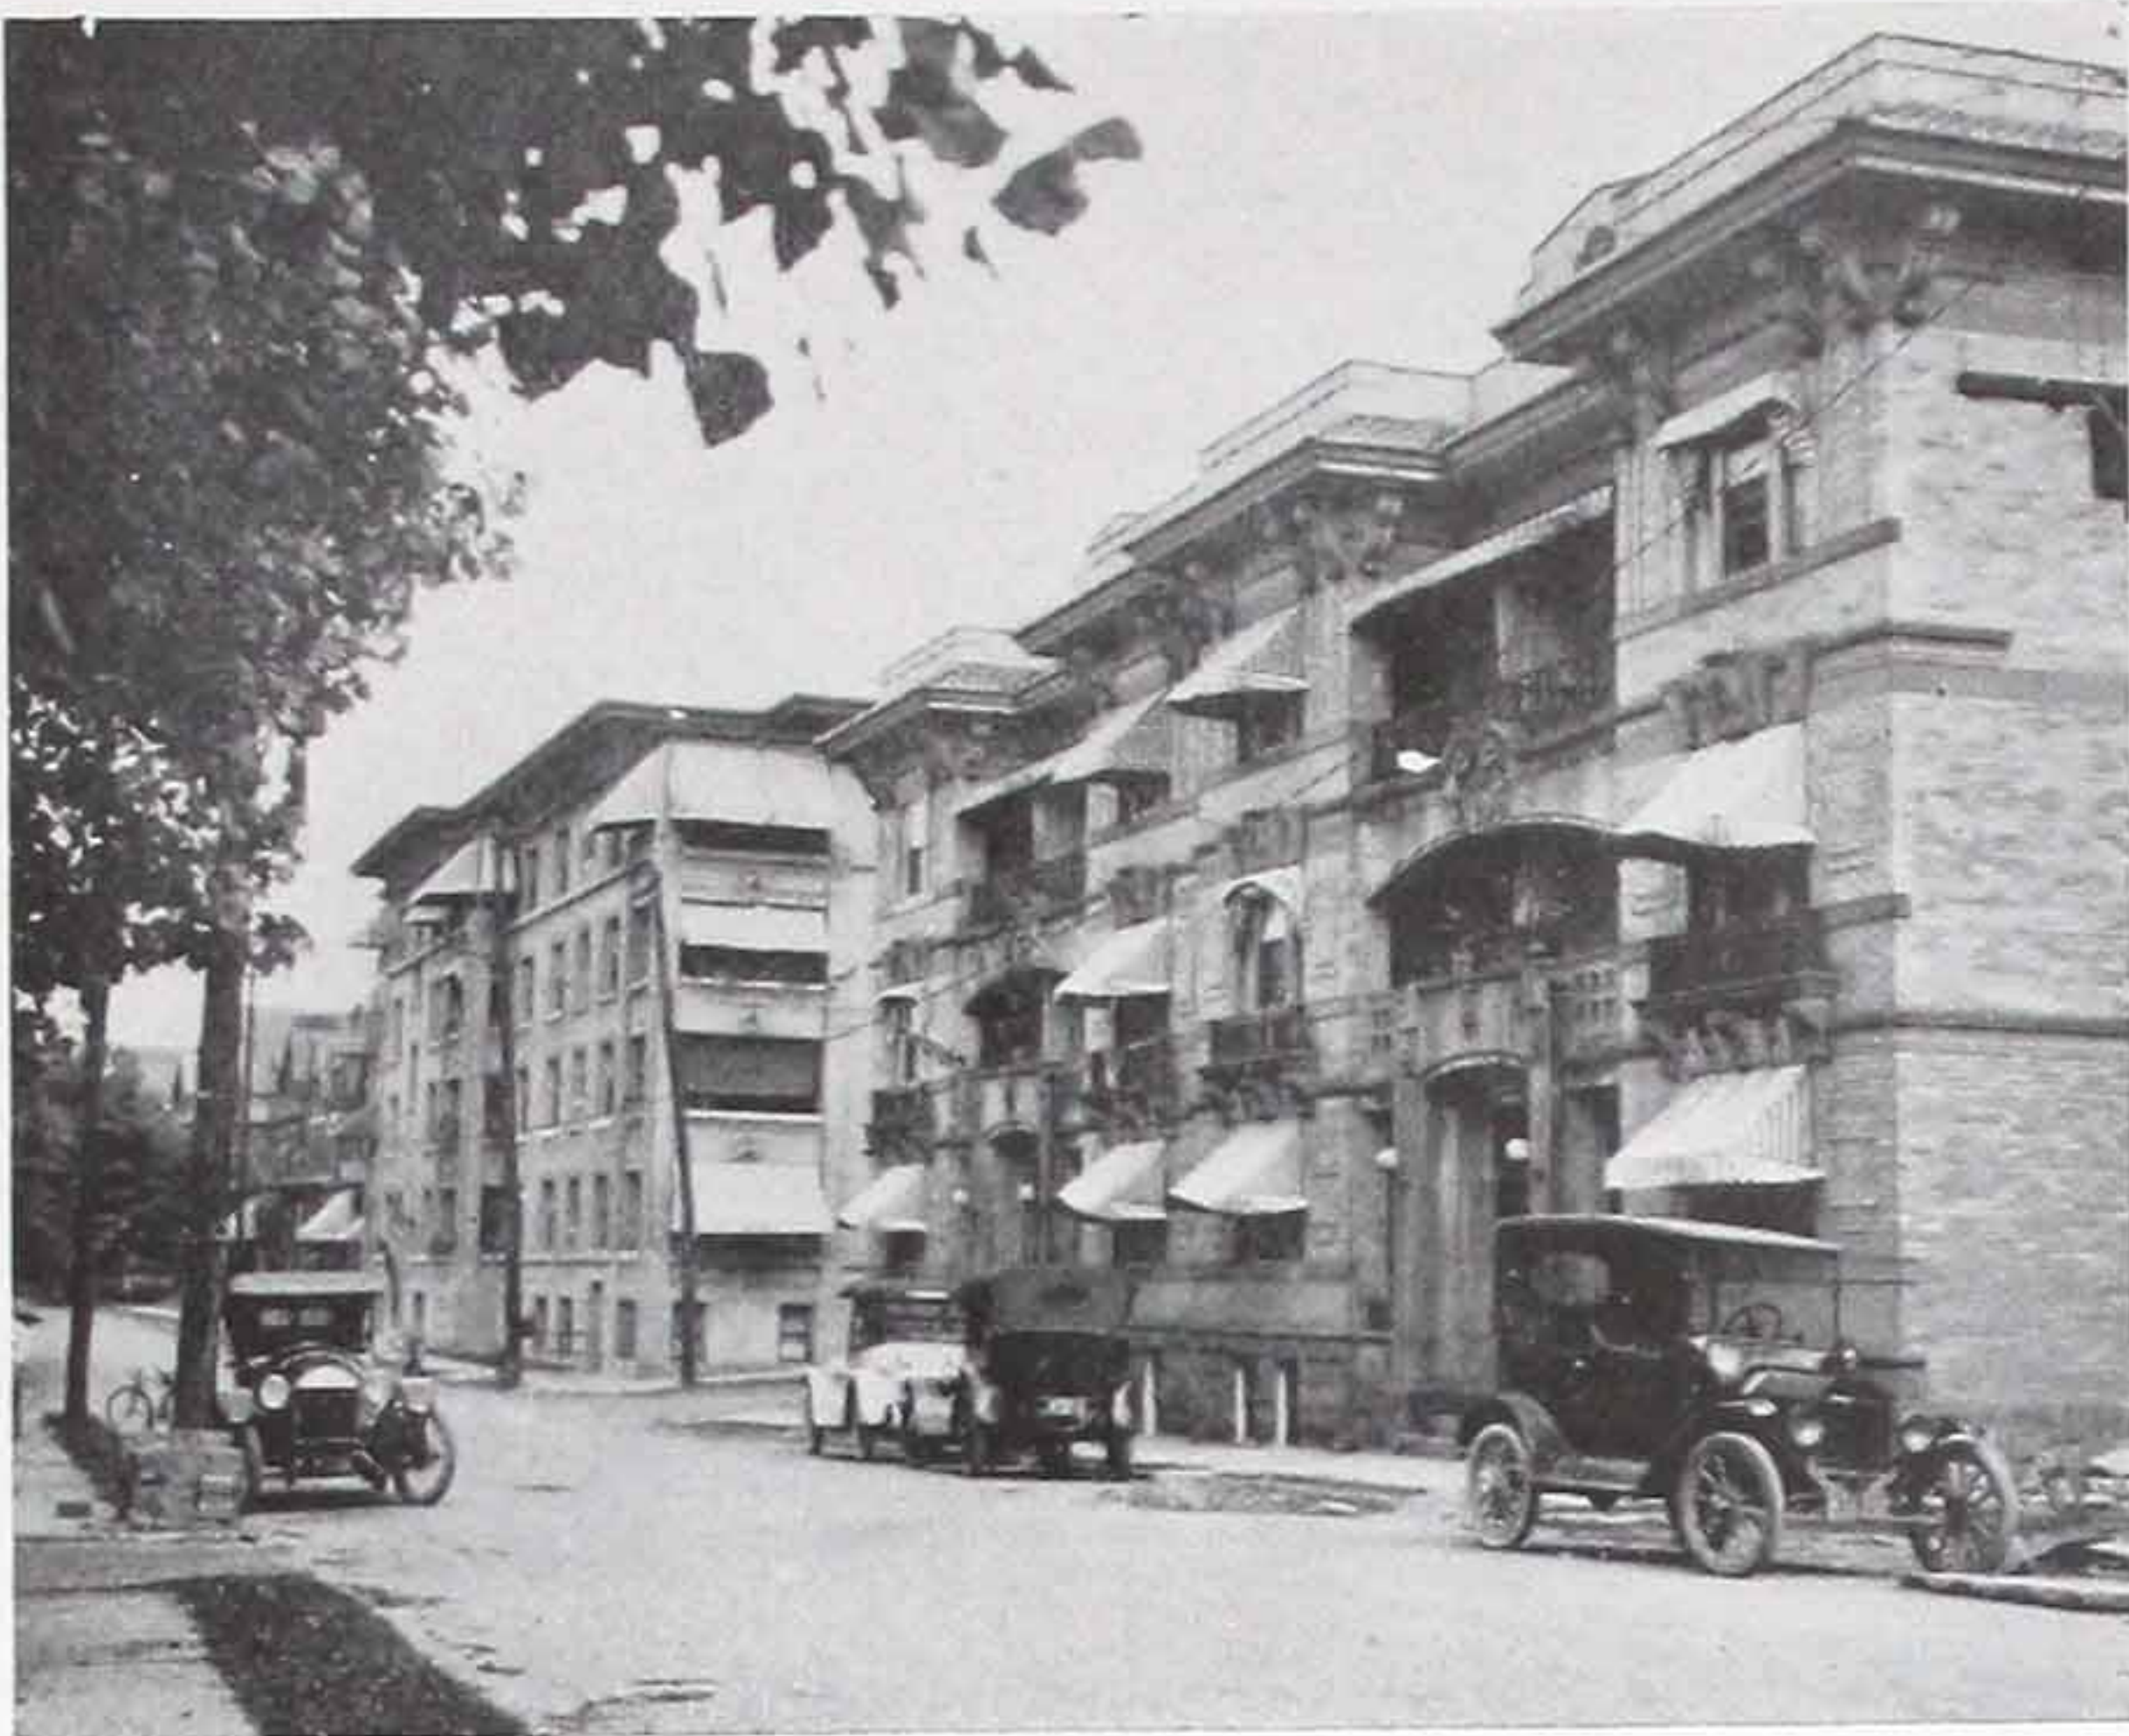
St. Regis, Chesapeake, and Chamberlin Apartments erected 1908. Equipped with steel pipe. Most of the hot water mains have already been replaced. See records Nos. 17, 18 and 19, page 14.

17. St. Regis Apts. Maryland and Howe.	18	1908	Cold water pipes too small and replaced in 1915. Hot water mains replaced 1915, account rust.	7 yrs.	7 yrs. Still good	See remarks
18-19. Chesapeake and Chamberlin Apts. Maryland and Howe.	12	1908	Gradually replacing hot water mains in basement.	s-10 yrs.	10 yrs. Still good	10 yrs. Still good

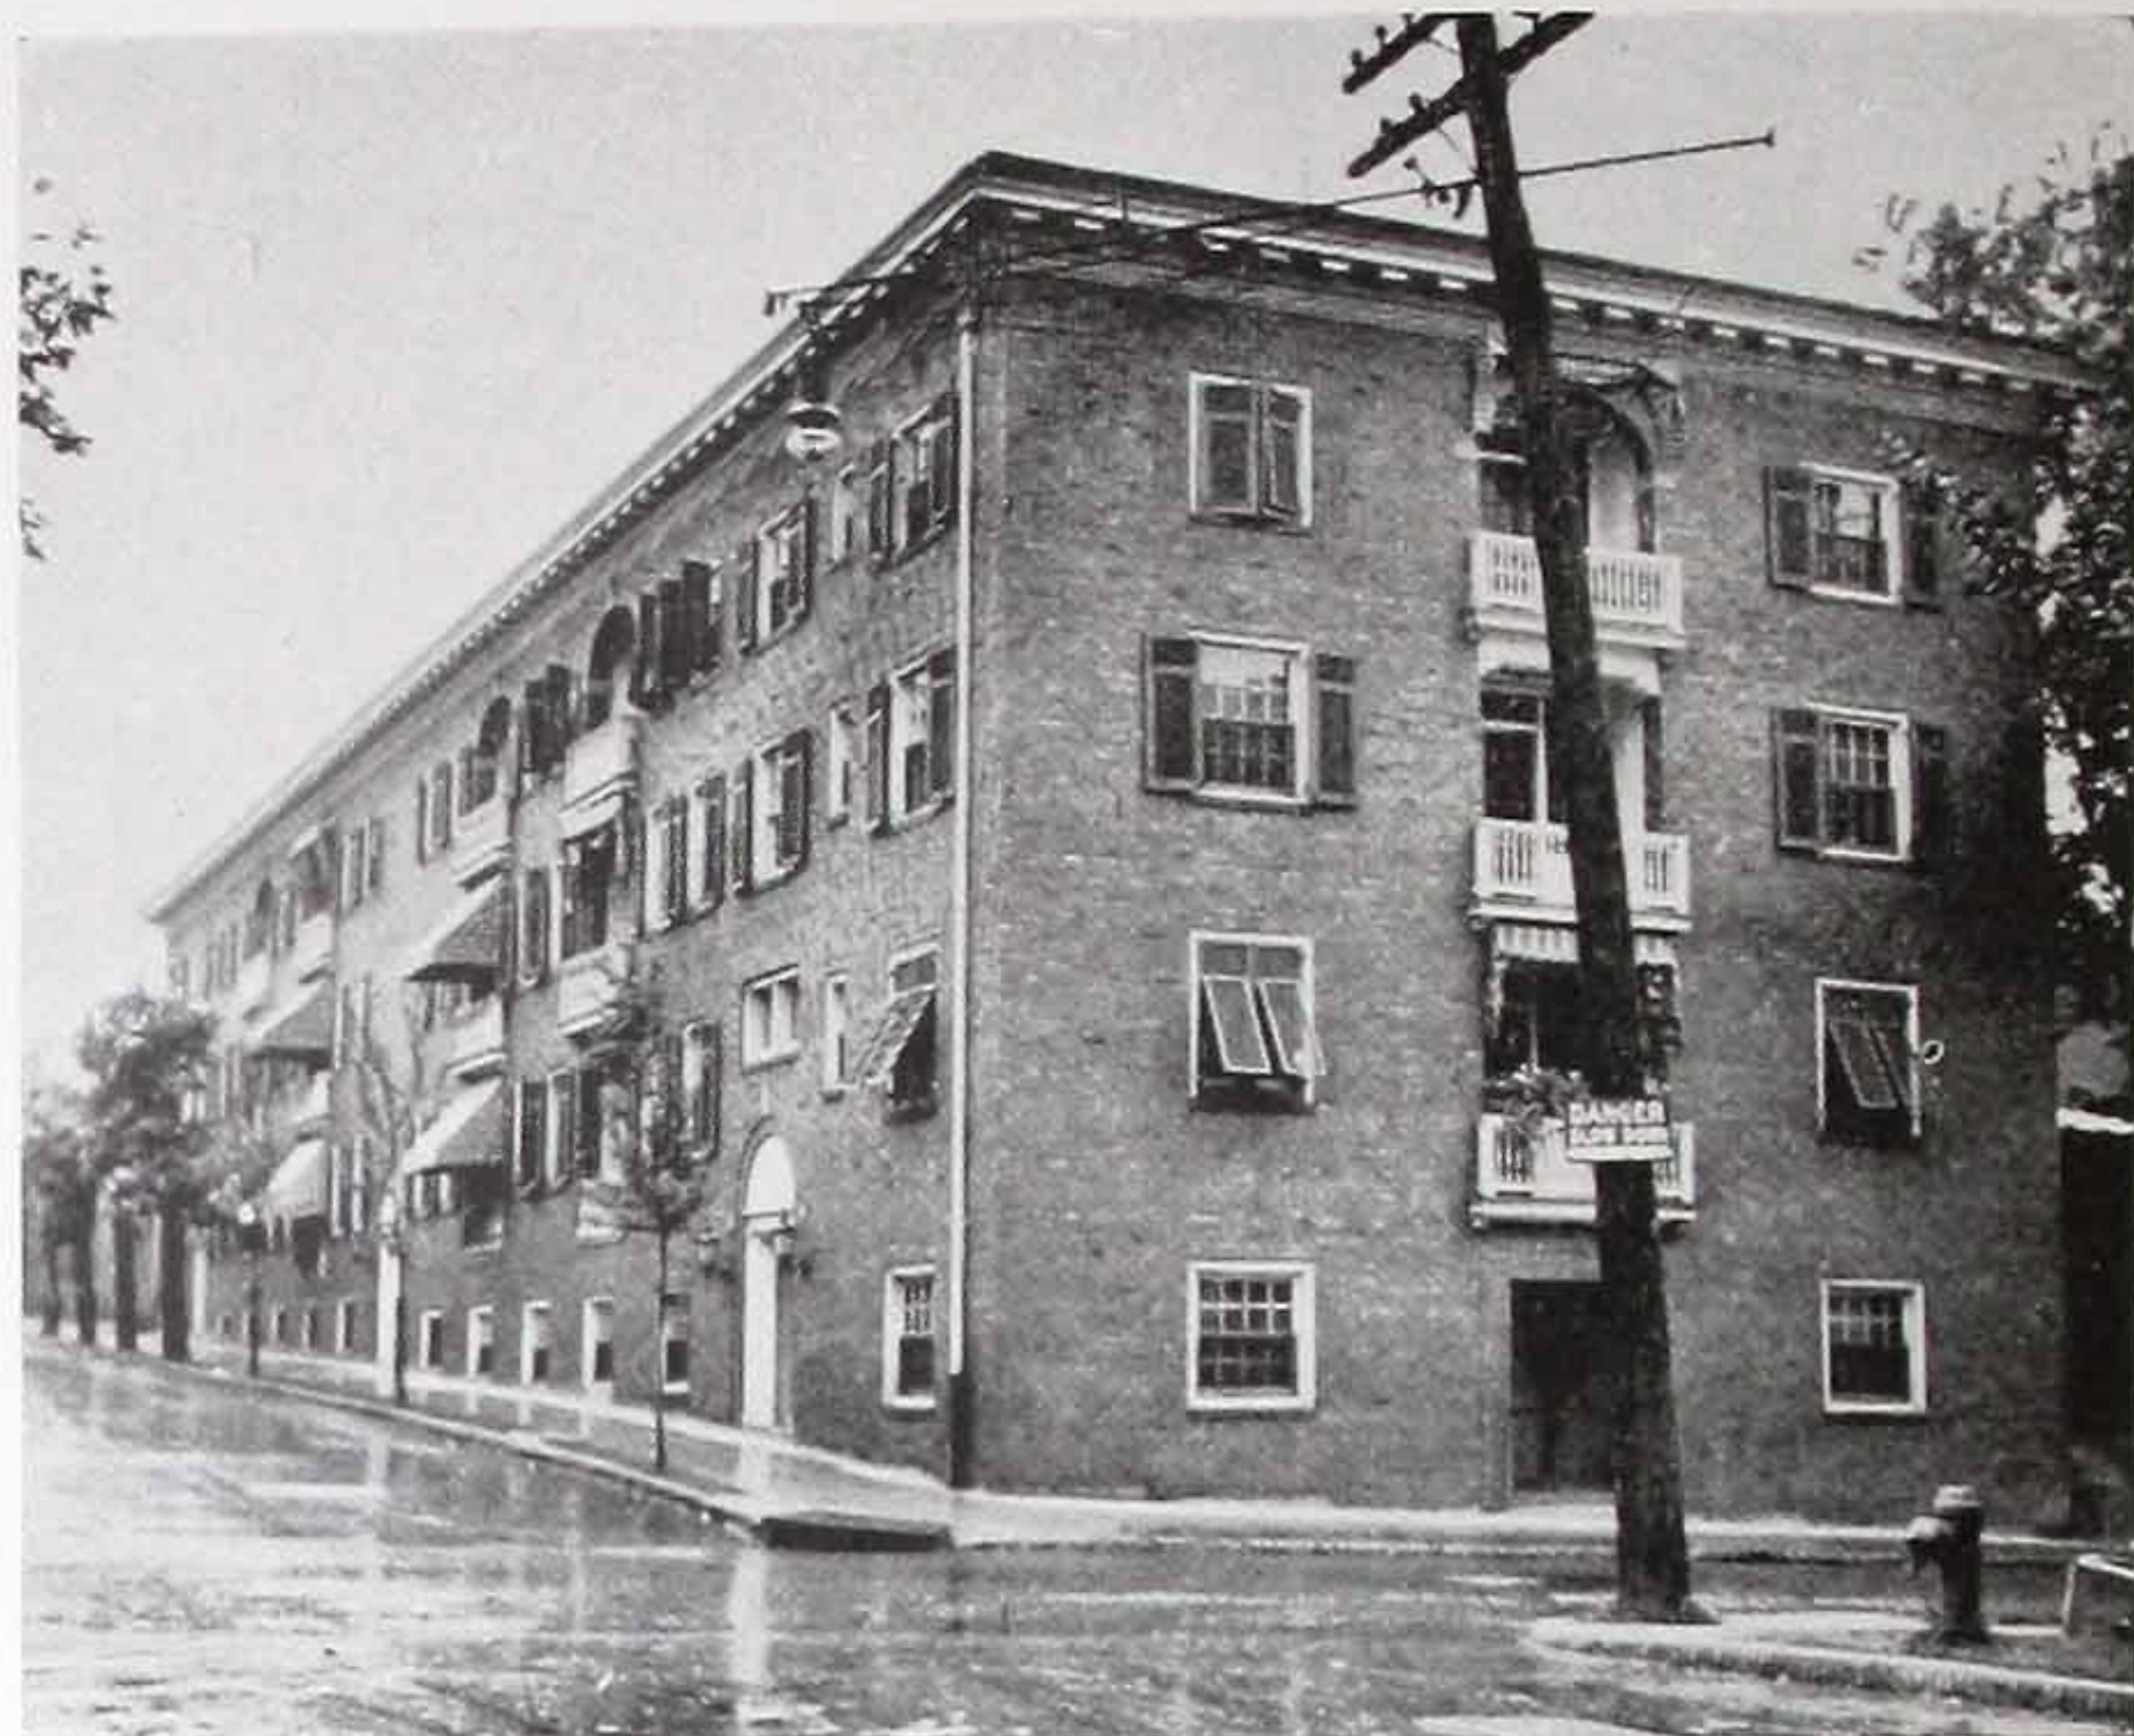
Negley Apartments, erected 1909. Hot water mains of steel, largely replaced between 1911 and 1914. Trouble with rusty water. See record No. 1, page 13.

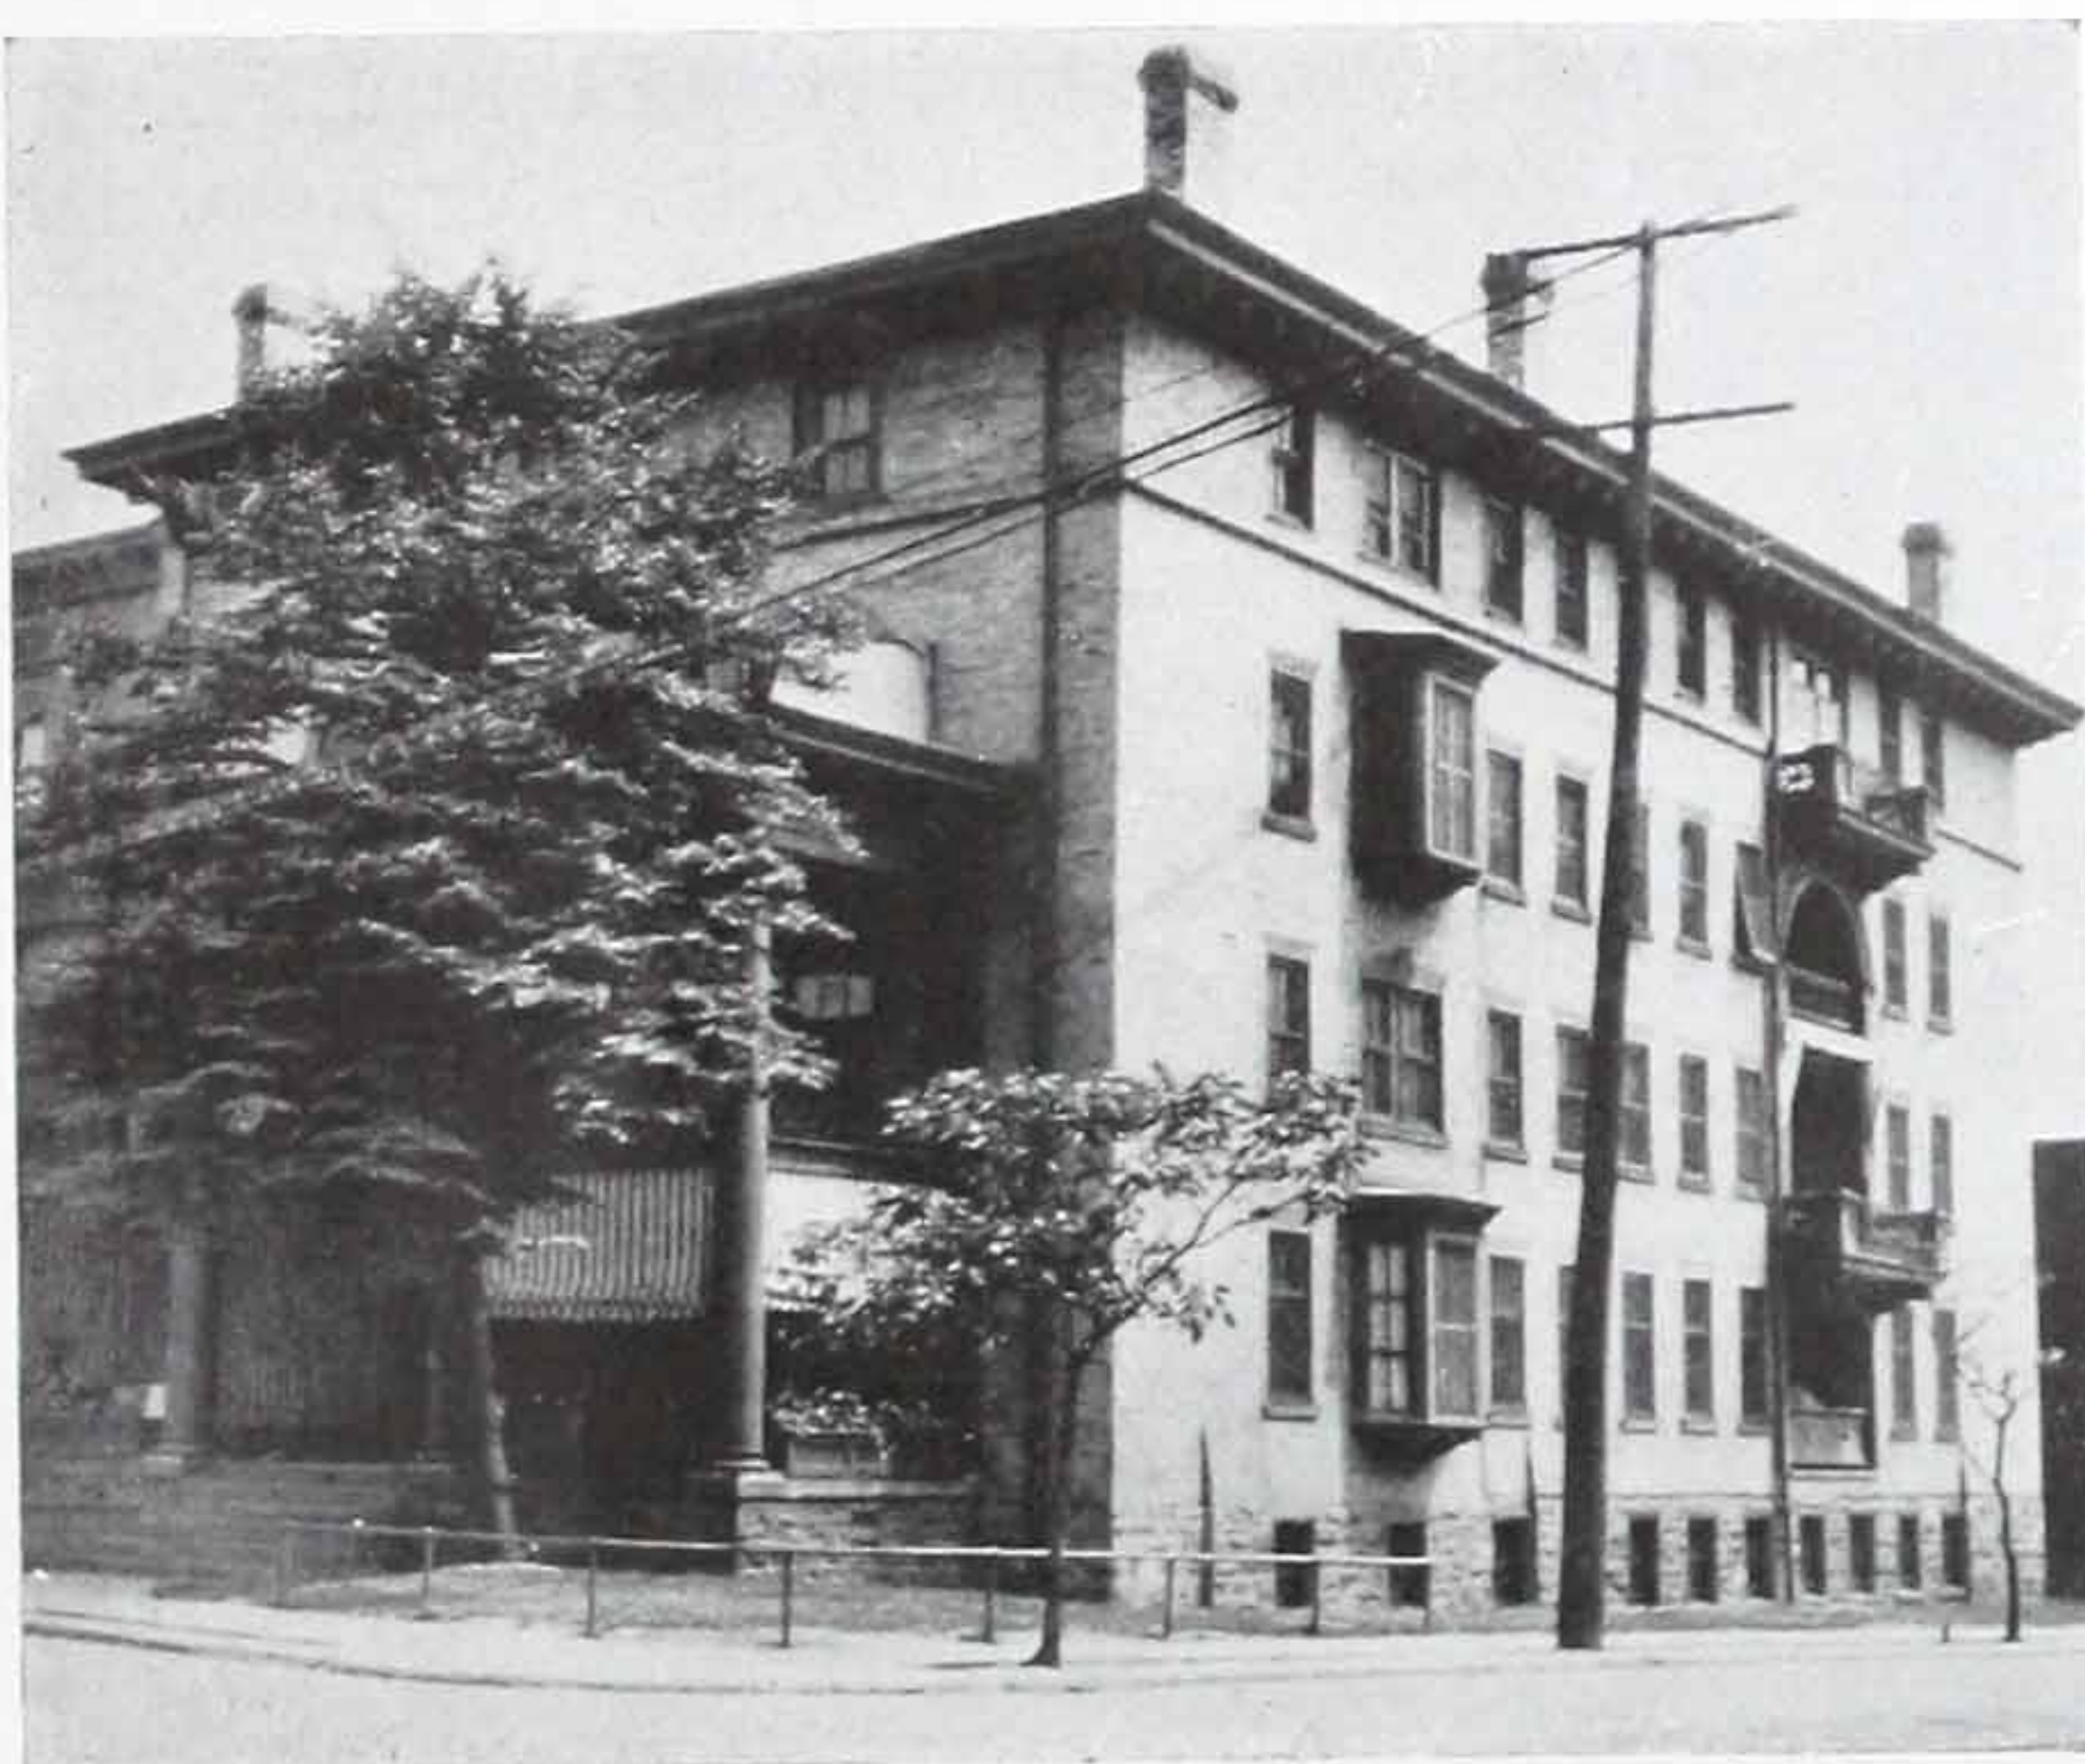
Kennett Apartments, erected 1902, equipped with brass pipe. Record No. 4, page 13. Typical of most apartments equipped with brass pipe, the hot water mains being badly corroded, after 10 to 15 years' service.
